Assessing Hurricane Katrina Vegetation Damage at Stennis Space Center using IKONOS Image Classification Techniques

Joseph P. Spruce and Kenton W. Ross
Science Systems and Applications, Inc.
John C. Stennis Space Center, MS 39529

ASPRS 2007 National Convention
Tampa, Florida, USA
May 6-11, 2007

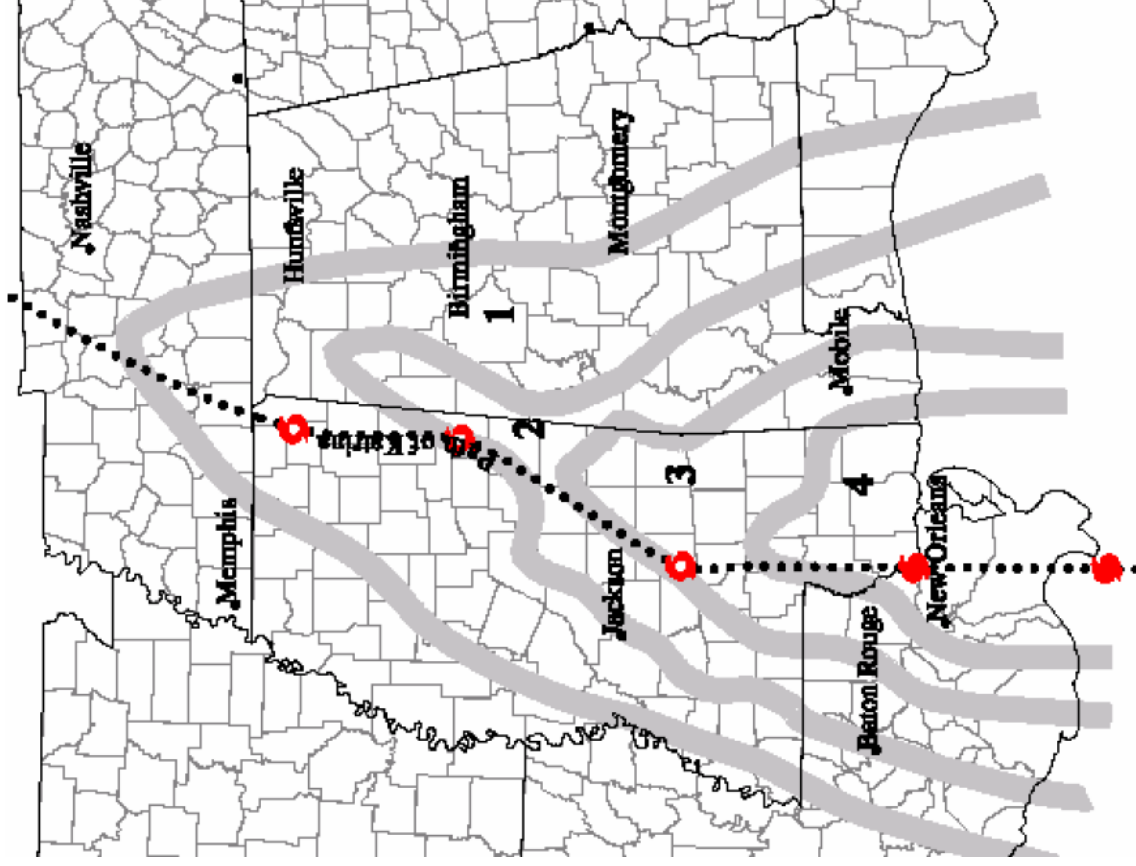
Preliminary Map of Katrina Forest Damage by USDA Forest Service

4 = Severe (includes SSC)

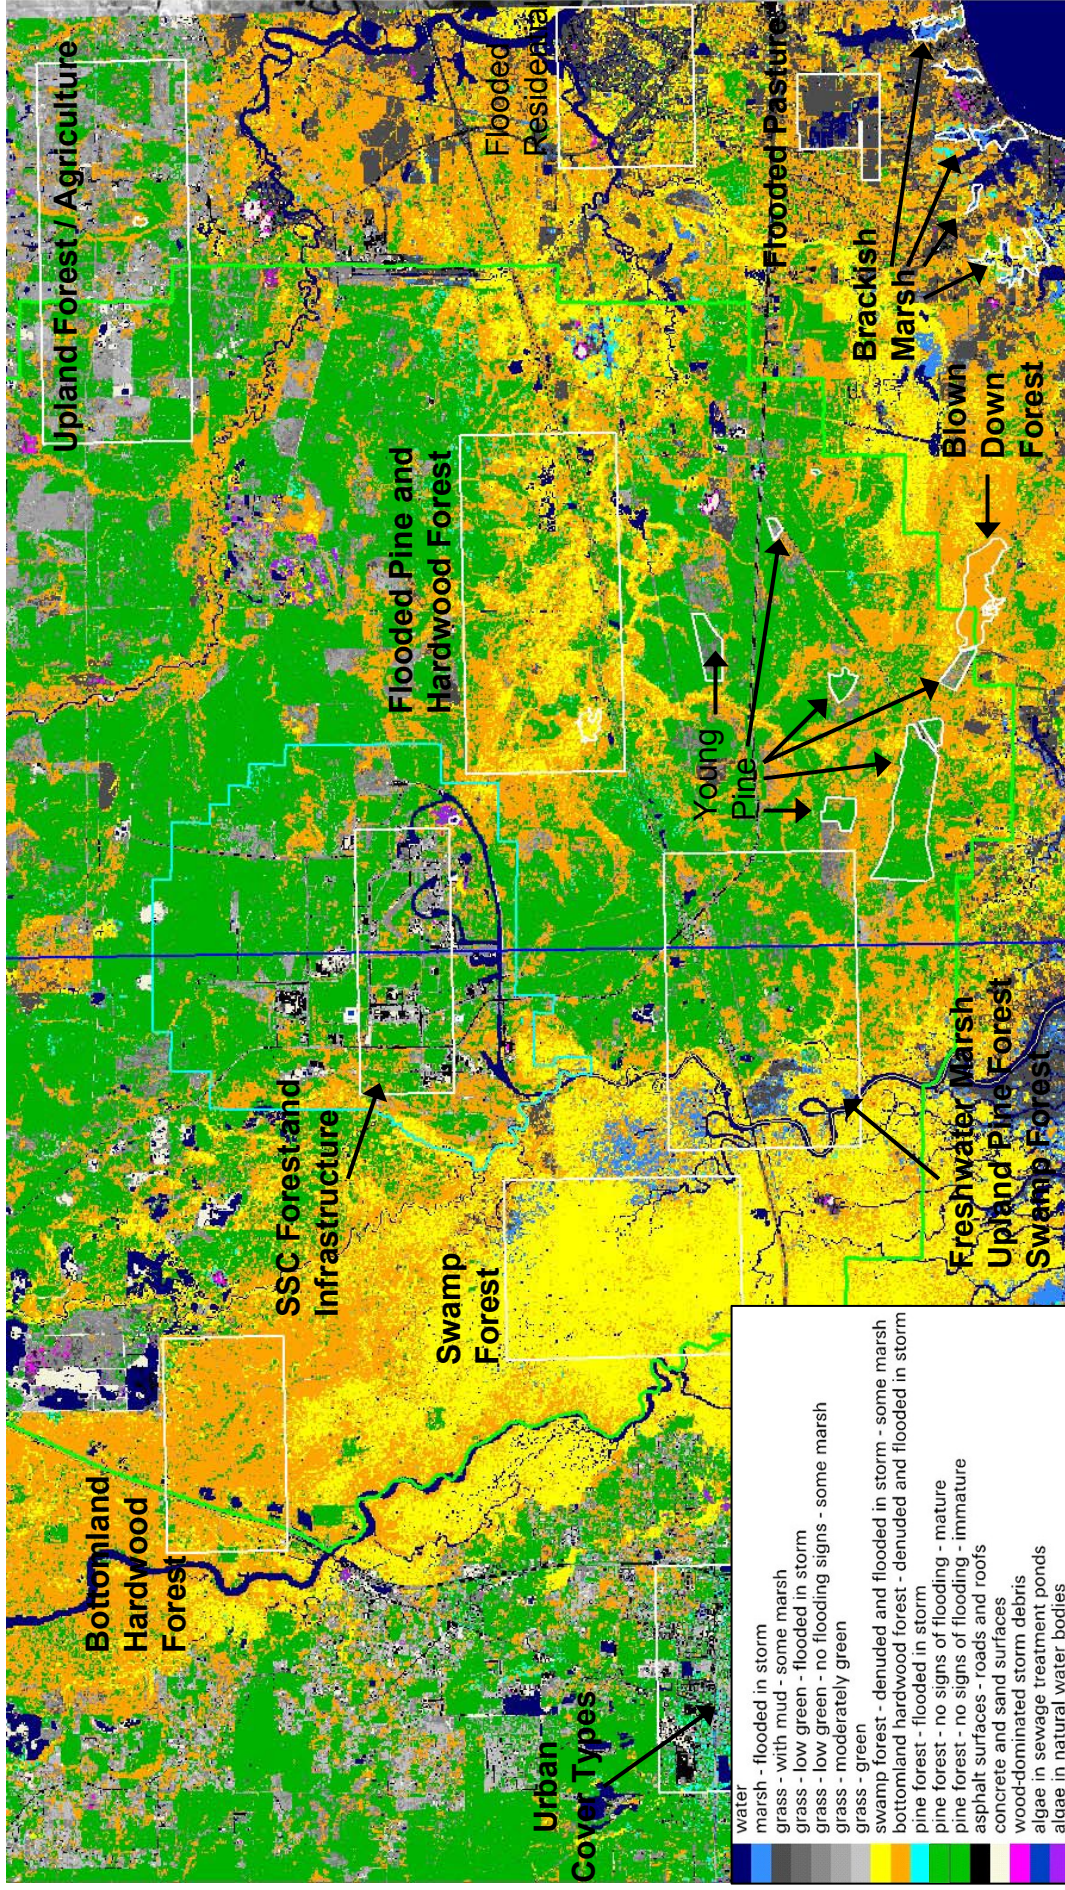
Final Classification Filtered (Without GIS Editing of Marsh)

- Marsh was mapped as one type, being sometimes confused with mud-covered grass and denuded swamp forest with sawgrass. GIS editing reduced this error.

- Some confusion occurred between pavement, roofing, and mud-covered herbaceous vegetation.
- Mapping of vegetation damage
 - Classification identified forest vegetation in terms of defoliation and flooding effects and agreed visually with IKONOS RGBs and aerial remote sensing data.

- Mud-covered grass was identified and was indicative of flooding.
 - Wood-dominated storm debris was classified for open areas, which is potentially useful for storm mitigation and fire hazards.

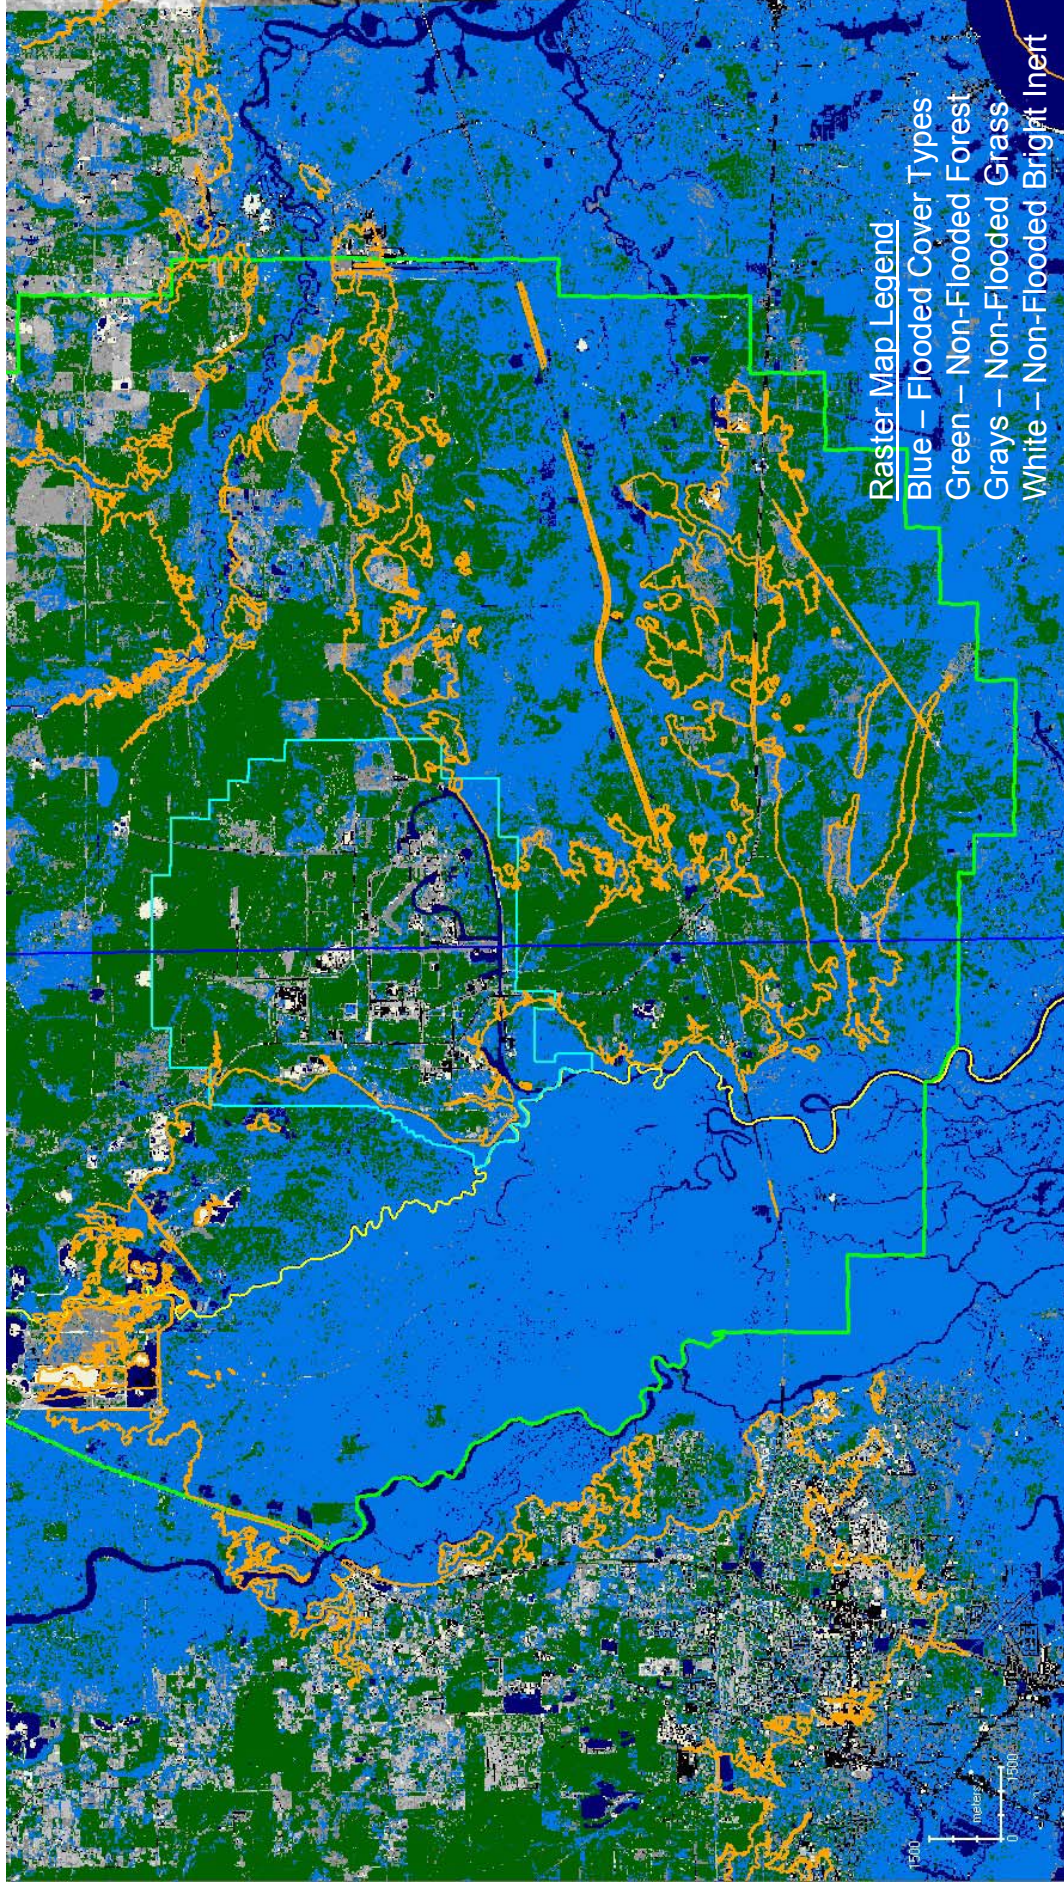
Final Classification Filtered - Recoded (Flood Related Classes in Sky Blue)

- Flooded vegetation types taken as a whole compared well to the FEMA storm surge map.
 - This product provided site managers with alternative geospatial information on SSC flood risk potential and forest damage status.
